Technical Note N-1096

CORROSION OF DSRV MATERIALS IN SEA WATER - 12 MONTHS  
NATURAL EXPOSURE AND 98 CYCLES IN PRESSURE VESSELS

Fred M. Reinhart and James F. Jenkins

May 1970

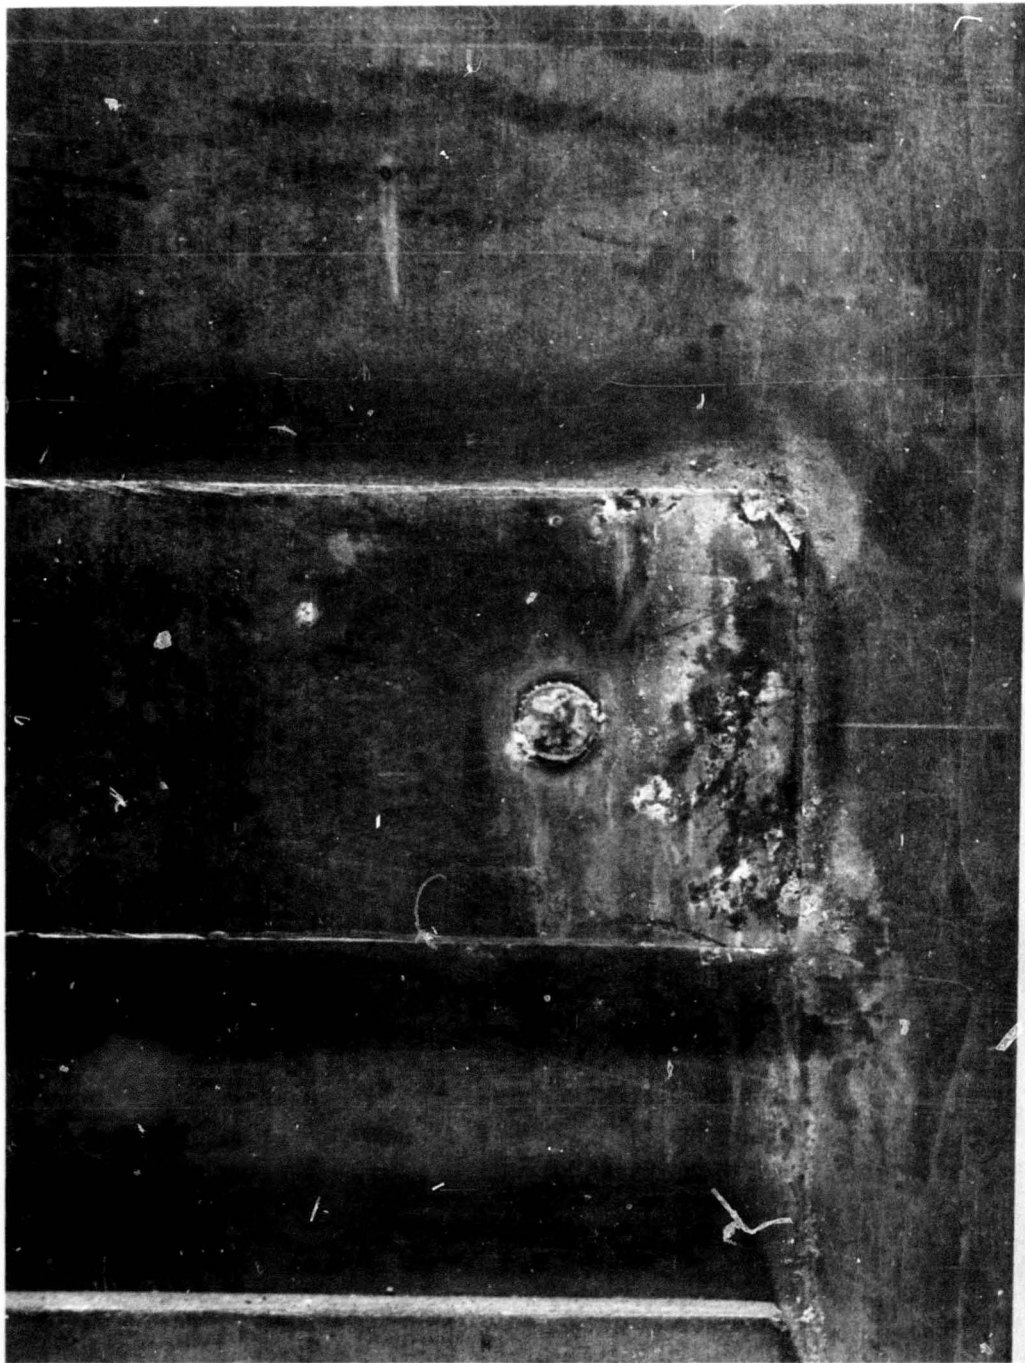
Specimen G8D. The specimen was covered with superficial rust stains. There was some pitting at the corners of the panel and on the attached strips as shown in Figure 3. This attack occurred during cycles 1 through 10 when the panel was in contact with the sides of the pressure vessel. The attack did not increase after the panel was insulated from further contact with the sides of the pressure vessel. The fasteners were uncorroded. There was a light film of corrosion at the faying surfaces indicating the inability of the zinc anode to completely prevent crevice corrosion. The zinc anode showed no visible consumption.

Figure 3. Arrested pitting on anodized 6061-T6 strip. Initiated by contact with steel vessel.
